# The use of Ceramic Coatings in Orthopaedic Implants

Titanium Nitride Ceramic  
Articulating against  
Polyethylene and Cartilage

implantcast

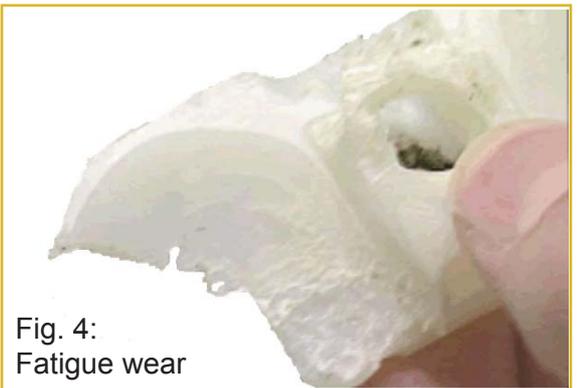
Fig. 4:  
Fatigue wear  
of polyethylene

The most commonly used orthopaedic implants are of the metal-on-polyethylene type. Polyethylene wear particle induced osteolysis has been identified as the main cause of failure of total knee arthroplasty and especially the occurrence of fatigue-type wear that can destroy a tibial inlay in less than 10 years, is of major concern (6, 7, 8).

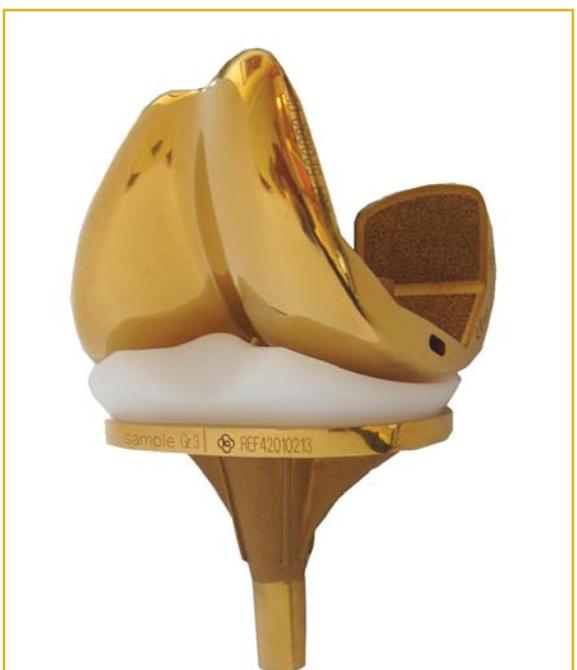
Fig. 5: The ACS® knee implant with  
Mobile Bearing

In the mobile knee designs, currently available, great differences can be found in the contact area between the femoral implant and the polyethylene articulating counter surface (15,16). The ACS® knee has the highest contact area at extension (where the highest load occurs) and at 60° of flexion.

The introduction of the Mobile Bearing into the knee designs by Goodfellow and O'Connor and the further improvement of the meniscal bearing design by Buechel and Pappas has lead to the view that three compartmental knee implant design can contribute substantially towards the reduction of polyethylene wear (11, 12, 13, 14).

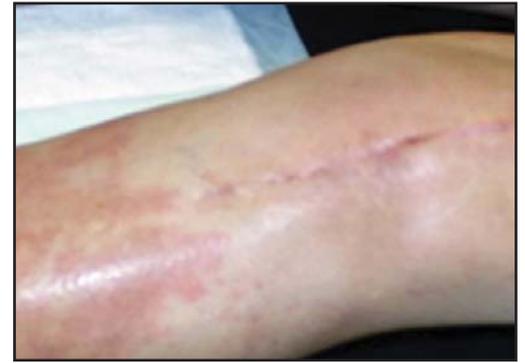
Fig. 10: Lymphadenitis in a patient with Ni-hypersensitivity after TKA

In the late 70 and 80's of the last century, some of the Cobalt Chromium implants had a small Nickel content to add to strength of the implant. Nickel is the primary cause for metal sensitivity, although some patients have shown to be hypersensitive to other metals such as Cobalt and Chromium.

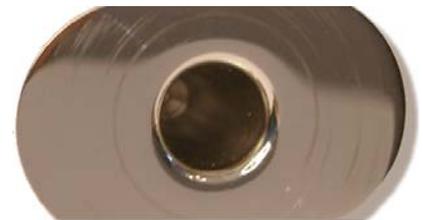
Fig. 12: Scratched non-coated CoCrMo tibial component

Wear simulator tests are usually done with implants that come right from production. However it is known that particles in the body such as bone chips and bone cement particles can lead to increased abrasive wear (26). Ceramic coated implants have a higher resistance against scratching (28, 29).

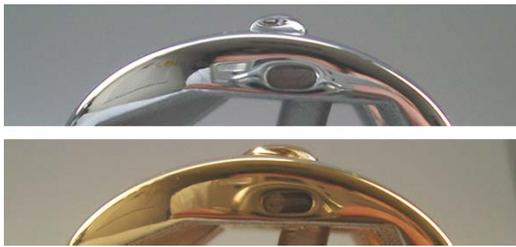
Fig. 16: Wettability of non coated and coated femoral components

When placing a droplet of de-ionised water on the surface of an implant, the contact angles can be measured. TiN shows to be more hydrophilic than non coated CrCoMo. A better wettability will increase the lubrication, decreasing the coefficient of friction and this will help to reduce the wear (29, 31).

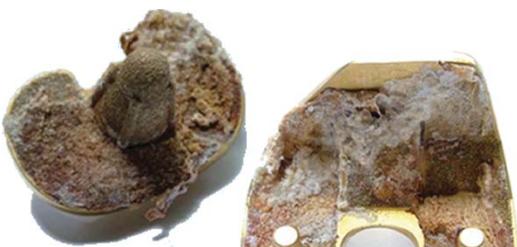
Fig. 18: Bone ingrowth in TiN coated CoCrMo knee replacement components

This lady received a Titanium Nitride coated knee implant, but unfortunately she fell during shopping at 3 months post-operatively. As she tore both collateral ligaments the implant had to be revised for a type with more intrinsic stability. Notice the abundant bone ingrowth on both components (pictures courtesy of Mr D. Woodnutt, consulting orthopaedic surgeon Morrision Hospital Swansea UK).

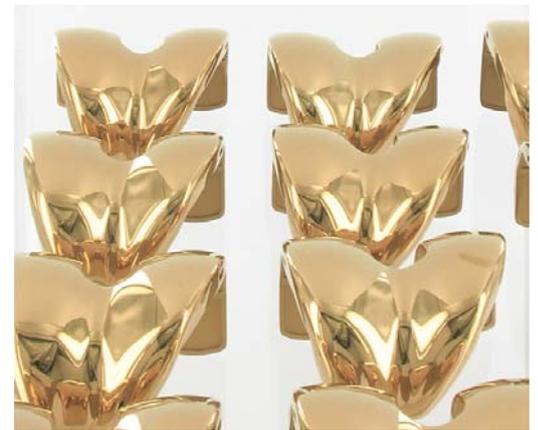
Fig. 20: TiN coated components

The application of the Titanium Nitride Ceramic coating is a Physical Vapour Deposition(\*). The name PVD stands for a wide range of applications each with its own physical characteristics. In order for the coating of an implant to be able to function long term it is crucial that the PVD process is reliable, reproducible and has proven itself in clinical application. Especially the adhesive strength of the coating onto the substrate is of vital importance. Various in-process and batch quality checks are performed.

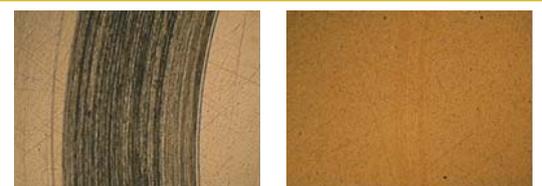
Fig. 24: Pin-on-Disk test of PMMA on TiN coated substrate.

As the main cause for scratches of implant components may be the presences of bone cement particles, a disk of PMMA bone cement is used against a TiN coated metal disk. No delamination is seen, not even at a load of 500 MPa, which is 50 times higher than the normal, vivo pressure in the knee, being less than 10MPa (26, 31, 34).
